Level 1, Premium Reserve Analysis

Littleton Village Metro District No. 2 Dry Creek & Broadway Littleton, CO. 80120

FINAL VERSION

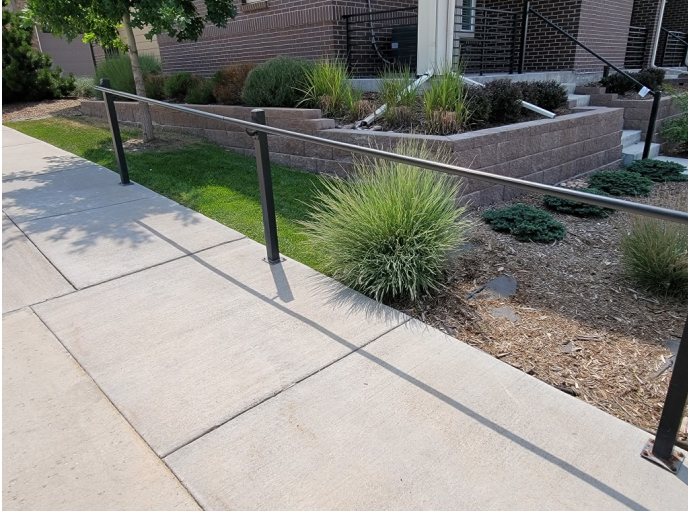
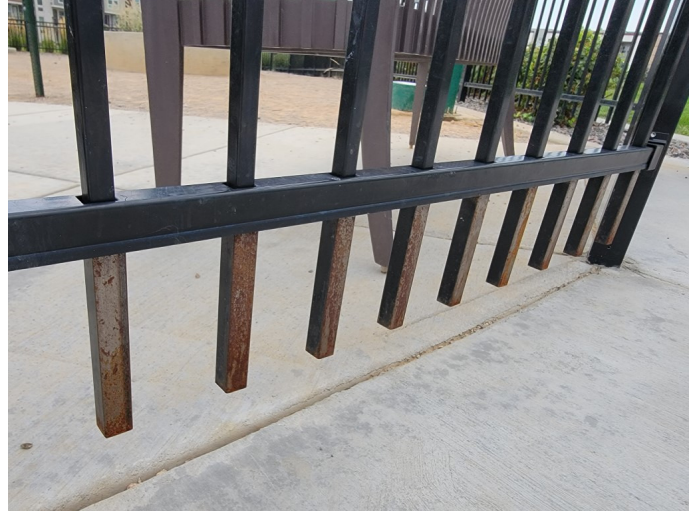
Comp #: 207 Iron Fencing/Rail - Repaint

- In this climate, we recommend repainting this component every 3 - 4 years to maintain appearance and protect metal surfaces.
- Remaining life based on current condition.

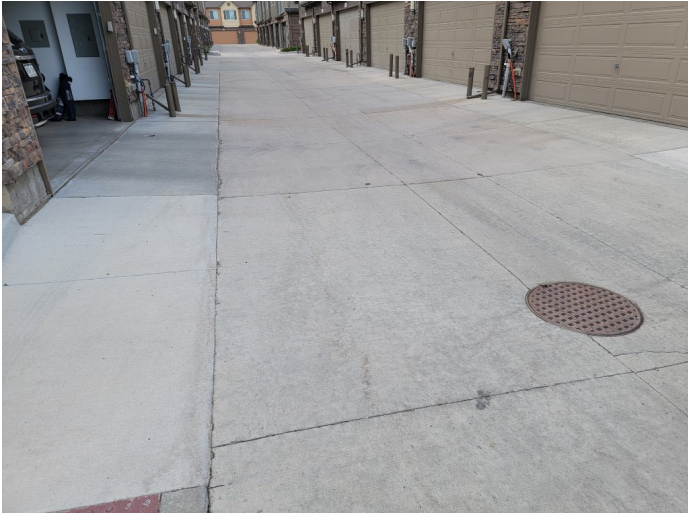
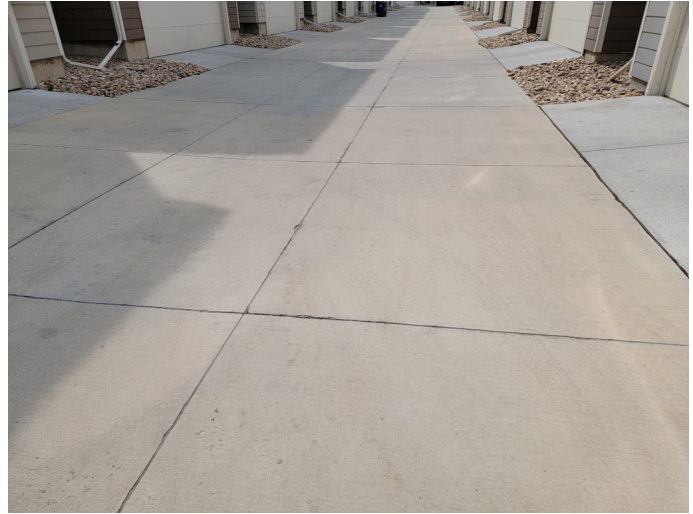
Comp #: 403 Concrete Alleys - Partial Replace

- It is unlikely that all concrete will fail and need to be replaced at the same time. Therefore, we recommend reserving an allowance for periodic repairs to a percentage of the total area.
- Coordinate this project with other concrete and/or asphalt projects for best cost estimates based on quantity of work.
- This line item is not intended to be interpreted as complete replacement.

Allowance to replace 5% of area every 4 yrs

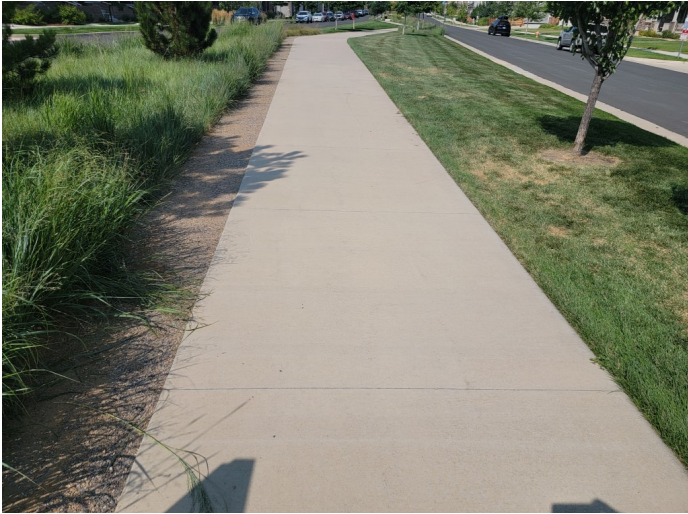
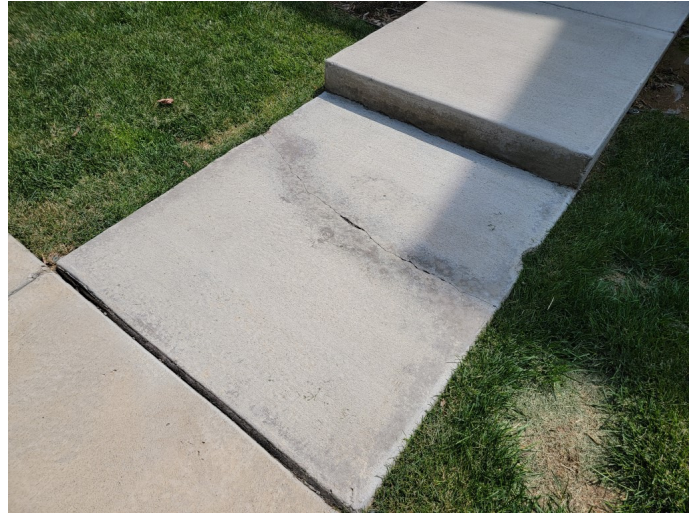
Comp #: 601 Concrete Flatwork - Partial Replace

- Similar to the concrete drive surfaces, it is unlikely all areas will fail and need to be replaced at the same time.
- Therefore, we set an allowance of 2% of the total area measured (2600 GSF) to be repaired every 4 years.
- As the property continues to age, it is possible the percentage or frequency of repairs will need to be adjusted in future Reserve Study updates.

Allowance to repair 2% of area every 4 years

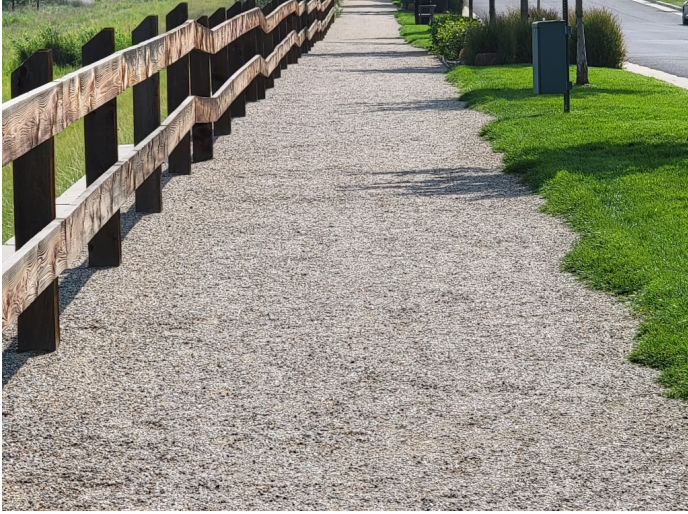
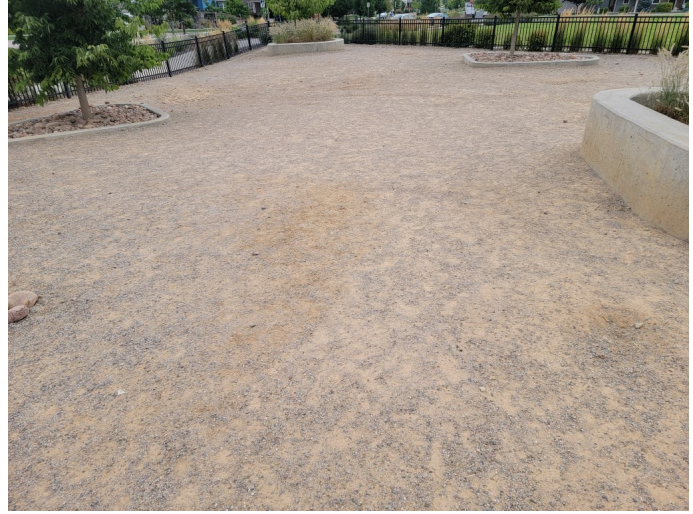
Comp #: 625 Breeze/Crushed Granite - Replenish

- These areas will be subject to frequent wash outs and are heavy use areas, which will result in continual high maintenance requirements
- We recommend addressing these paths every 4 - 5 years with new material and cutting back the overgrown areas.

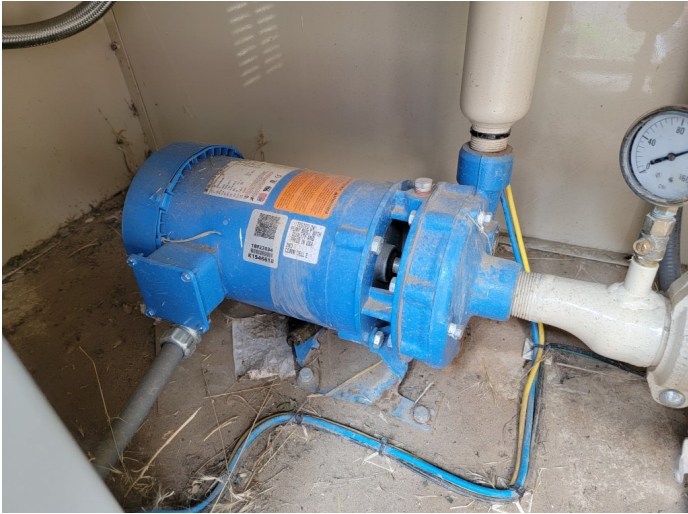
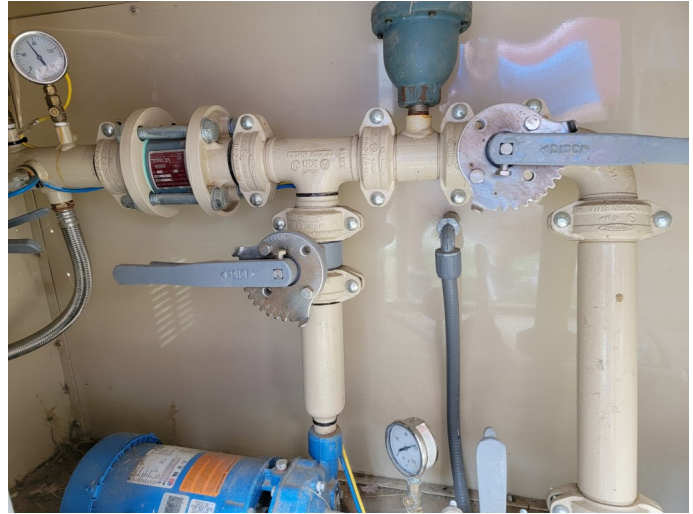
Comp #: 727 Pump Station - Replace

- The average life expectancy for pumps range from 5 - 10 years, depending on the level of use and maintenance.

Best Cost: **\$3,300**
\$1100/pump; Estimate to replace

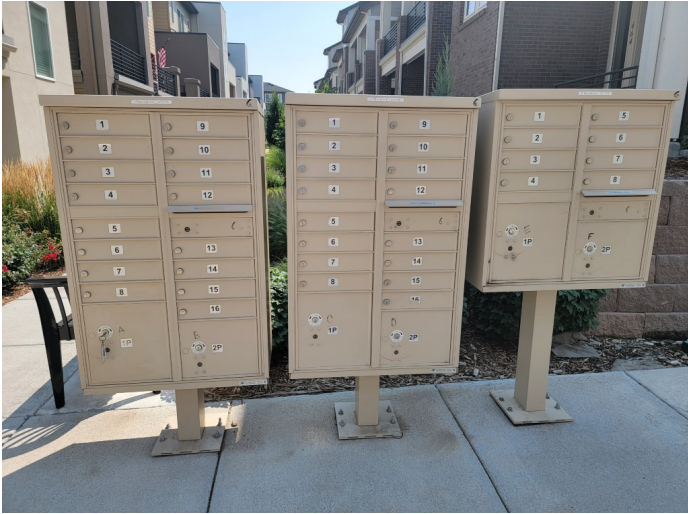
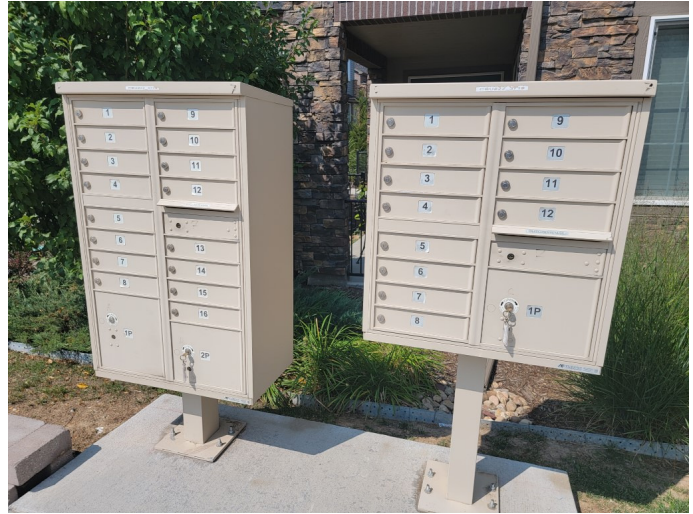
Comp #: 803 Mailboxes - Replace

- According to several manufacturers, the typical life expectancy for this type of mailbox is 15 - 20 years in this environment.
- Remaining life is based on average age of all units.
- Per new Postal regulations effective 2012, "all customers are responsible for repairs and replacement of keys, locks, or the boxes/cluster units themselves".

Best Cost: *\$50,600*
\$2300/CBU; Estimate to replace

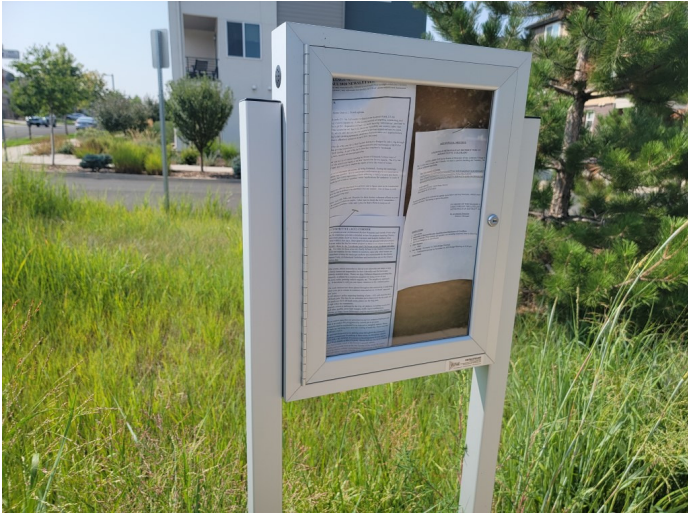
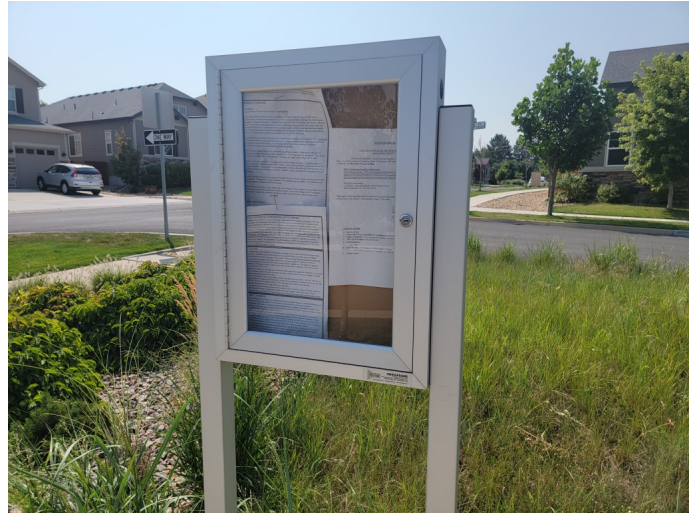
Comp #: 811 Message Boards - Replace

- Replacement cost for these boards is too small for separate Reserve designation. Replace as needed with general funds, as opposed to from a Reserve account.

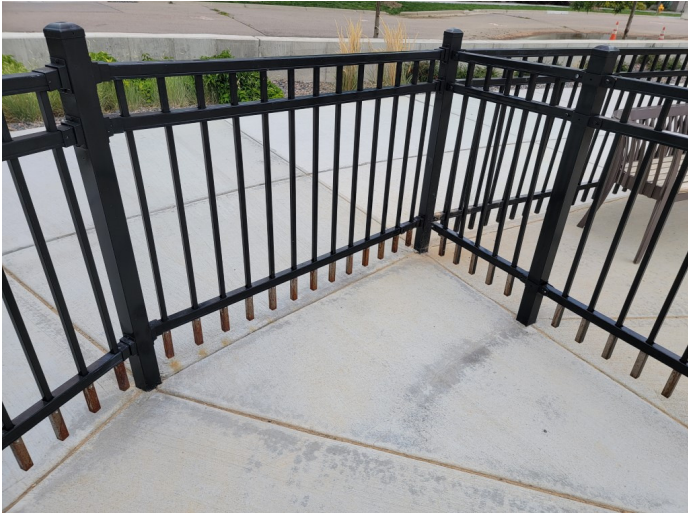
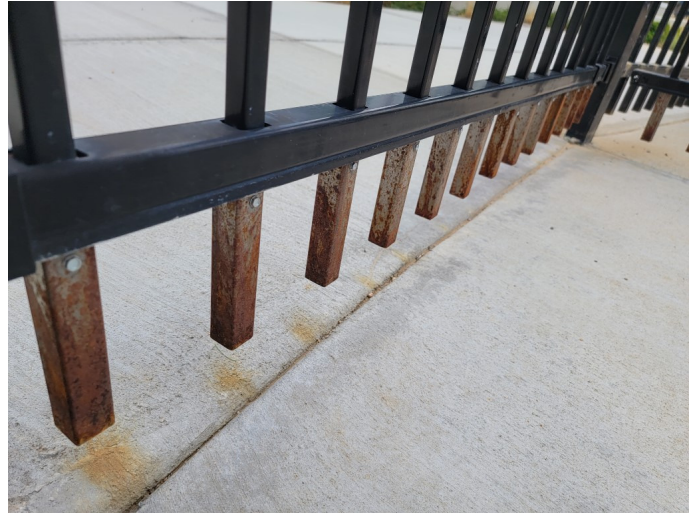
Comp #: 1002 Aluminum Fencing - Replace

- Bottom rungs of the pickets are rusted, as it doesn't appear these were ever painted or coated.
- The average life expectancy for metal fences ranges between 25 - 30 years, depending on maintenance schedules and exposure to elements.
- The remaining life is based on age of fence and observed conditions.

Best Cost: **\$15,950**
\$55/LF; Estimate to replace

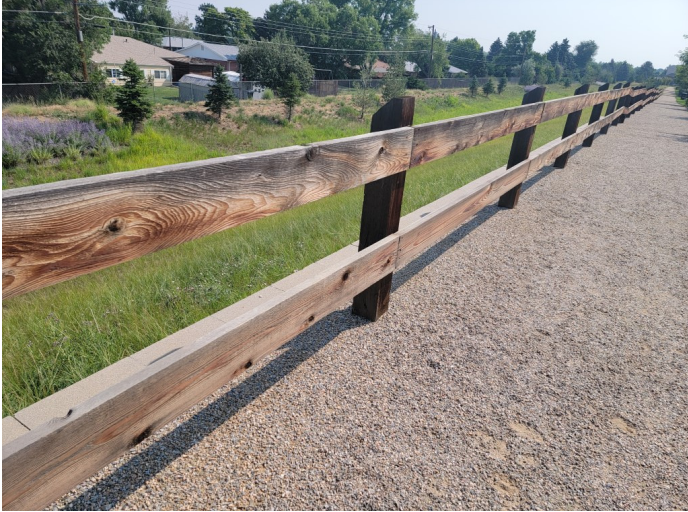
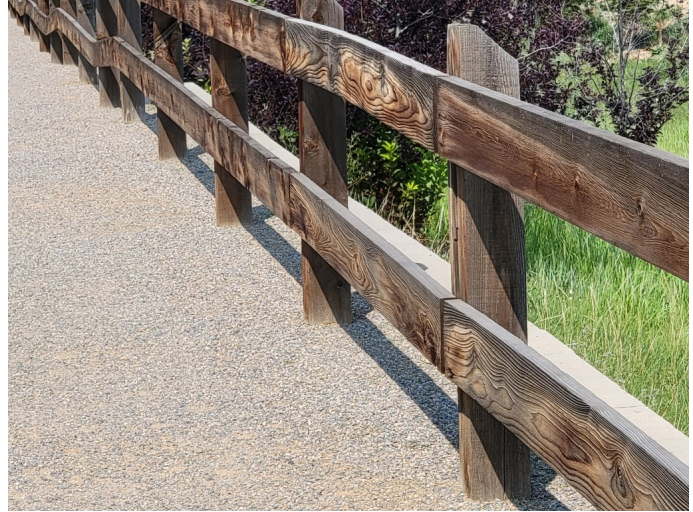
Comp #: 1009 2 Rail Fencing - Major Repairs

- This fence is a heavy duty cedar wood that will have an extended life expectancy.
- Typically, sections can be replaced as needed to maintain the integrity of the fence and the new sections will eventually blend in with the older sections.
- With no expectancy for complete replacement, we recommend establishing funds for periodic major repairs, as opposed to replacement as a whole.

Allowance for major repairs

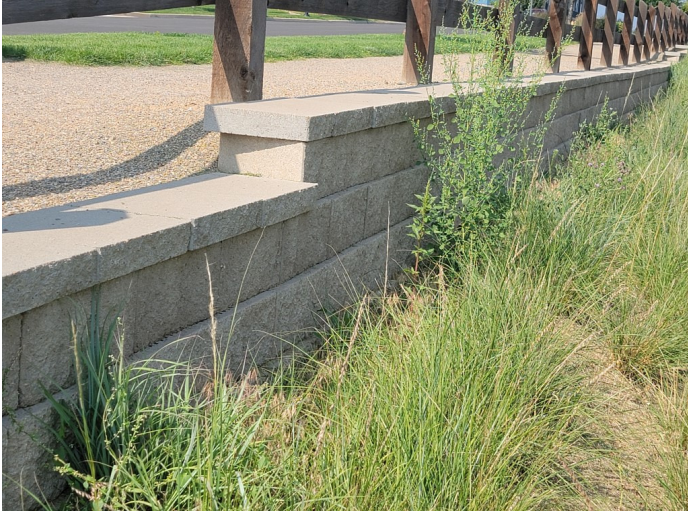
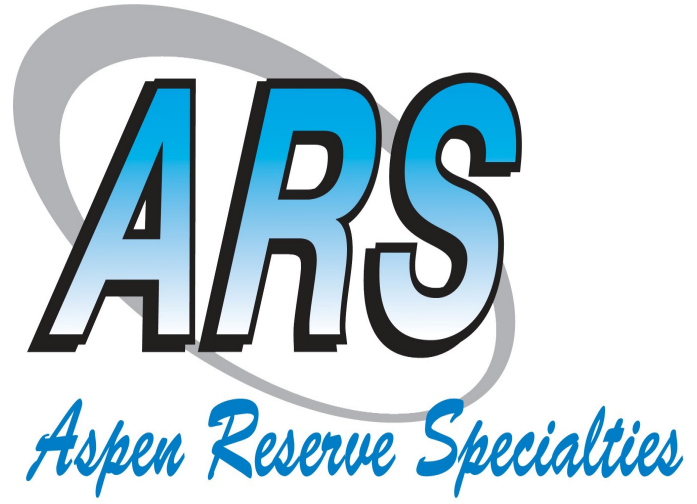
Comp #: 1011 Retaining Wall - Major Repairs

- As long as block wall was installed conforming to county code requirements, this wall should have an extended useful life.
- This type of material has an indefinite life expectancy and complete replacement is unlikely.
- However, due to the volume of retaining walls throughout the community, we recommend establishing a Reserve allowance for periodic repairs to maintain appearance and functionality of the wall.

Allowance for major repairs

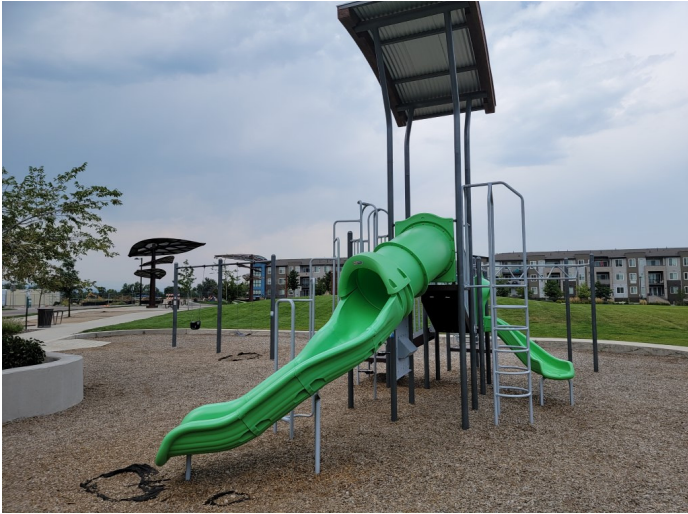
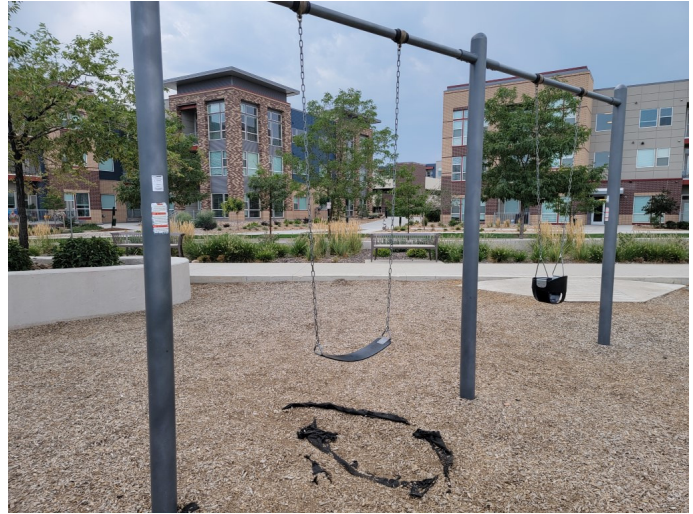
Comp #: 1301 Play Equipment - Replace

- Depending on overall level of use and care, the average life expectancy for play equipment ranges from 15 - 18 years.
- Expect high use for this facility due to the demographics of the community with the majority being young families with children.
- Manufacturer of equipment is "Little Tykes".

Estimate to replace and install with similar type

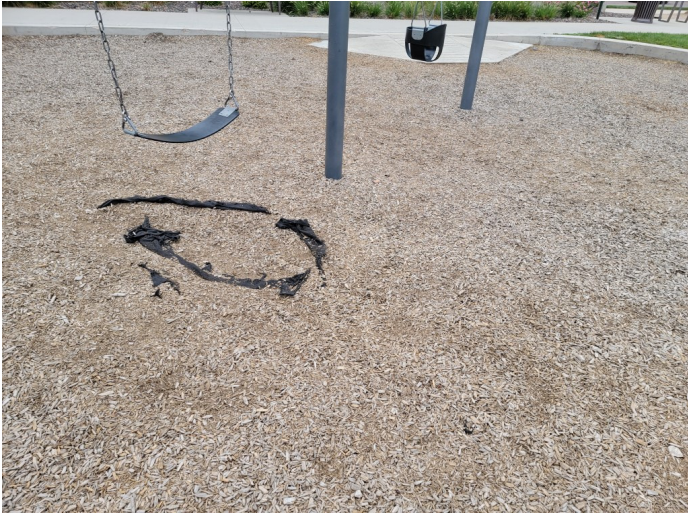
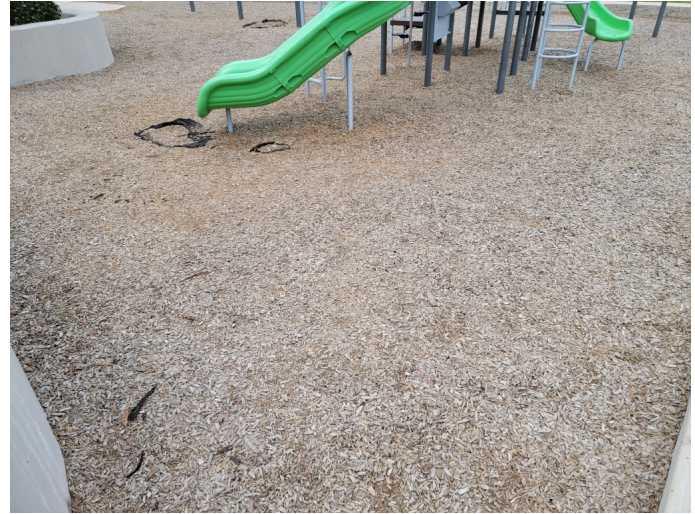
Comp #: 1303 Tot Lot Groundcover - Refill

- There was some signs of the weed barrier showing through the groundcover in low areas at the end of the slides and under the swing sets.
- Depending on the level of use and care, expect to refill groundcover bed every 3 to 5 years to maintain appearance and ensure proper function as a safety component.

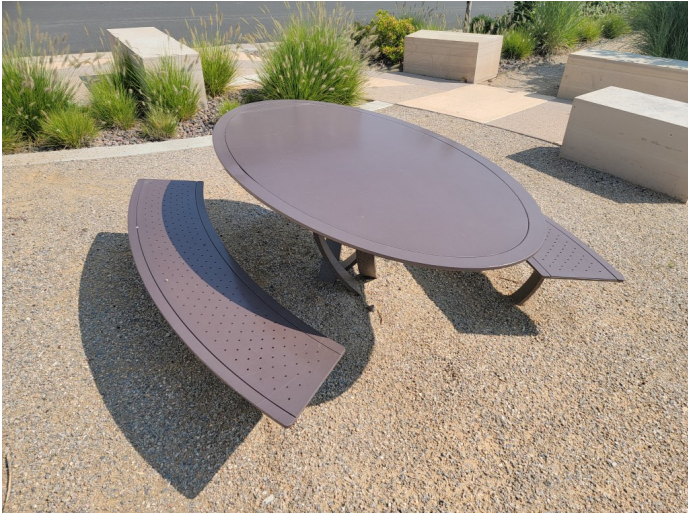
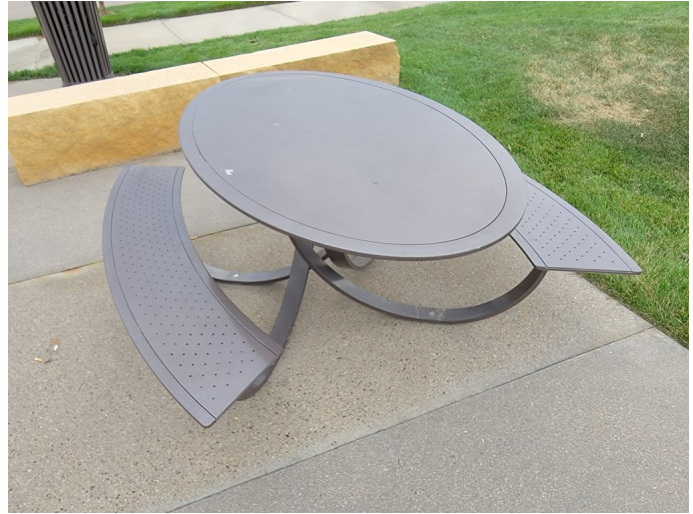
Comp #: 1306 Picnic Tables - Replace

- Expect to replace park equipment approximately every 15 - 18 years to maintain appearance.
- Remaining life based on current age.

\$1450/table; Estimate to replace with similar

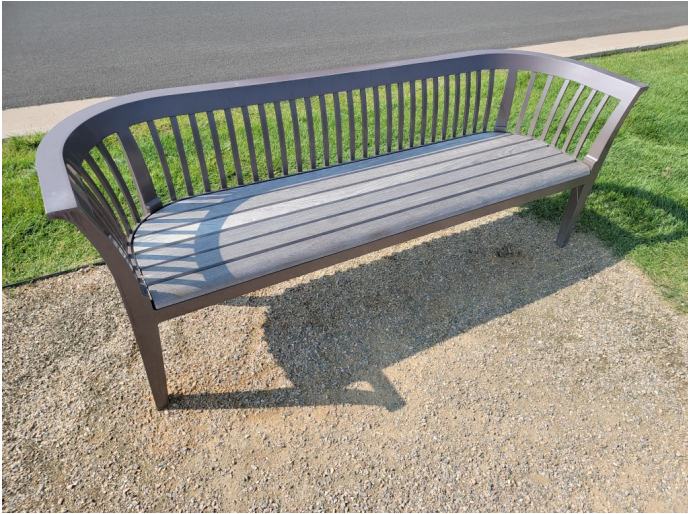
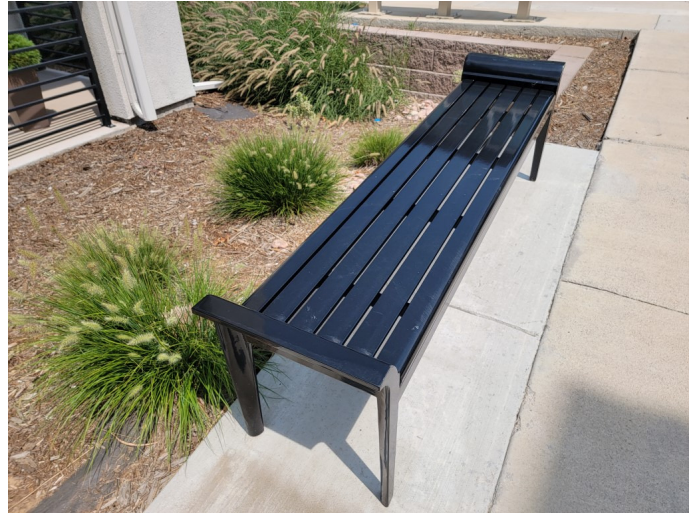
Comp #: 1307 Benches - Replace

- The average life expectancy for this type of furniture generally ranges between 10 - 15 years, depending on quality and levels of use and care.
- The remaining life is based on the average age of all furnishings.

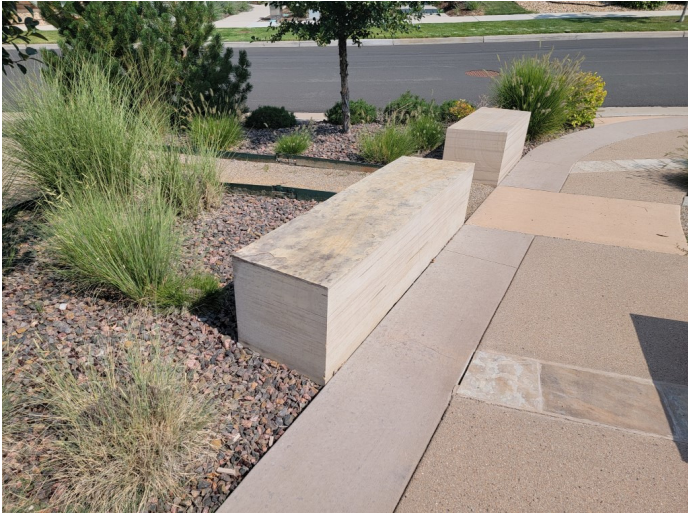
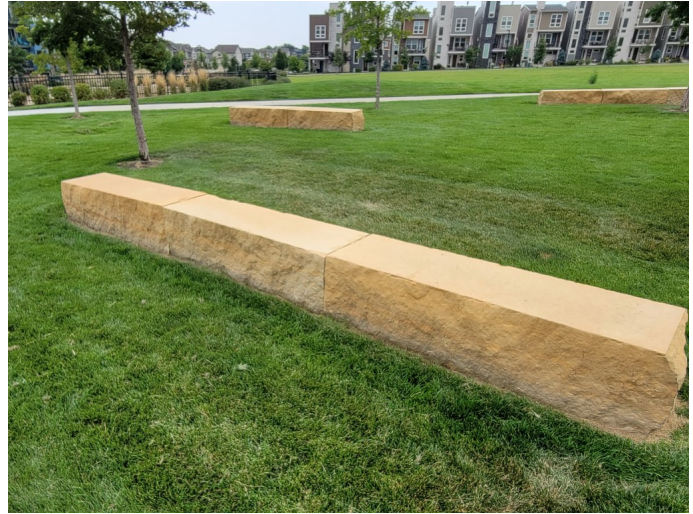
Comp #: 1307 Flagstone Benches - Replace

- These will have an indefinite life expectancy and replacement is unlikely.
- Continue to monitor conditions and adjust, or add funding in future Reserve Study updates if necessary

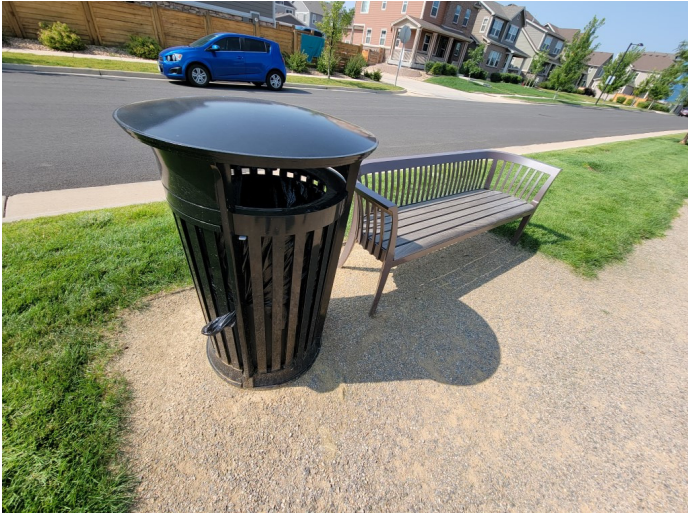
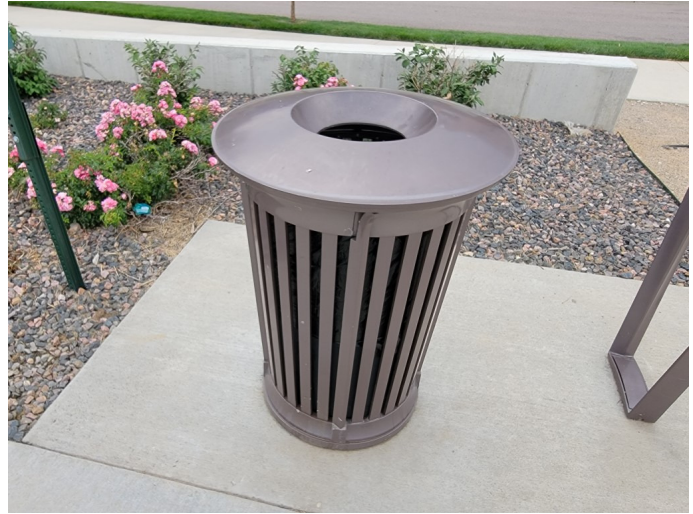
Comp #: 1308 Trash Receptacles - Replace

- The average life expectancy for this type of furniture generally ranges between 10 - 15 years, depending on quality and levels of use and care.
- The remaining life is based on the average age of all furnishings.

Best Cost: **\$12,000**
\$1000/unit; Estimate to replace

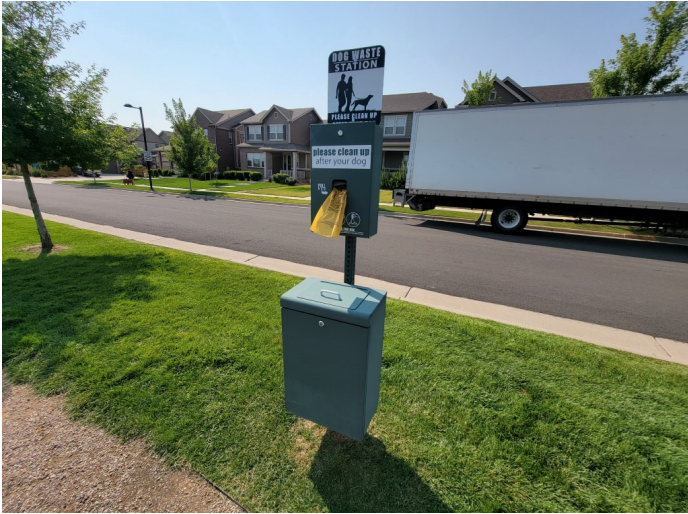
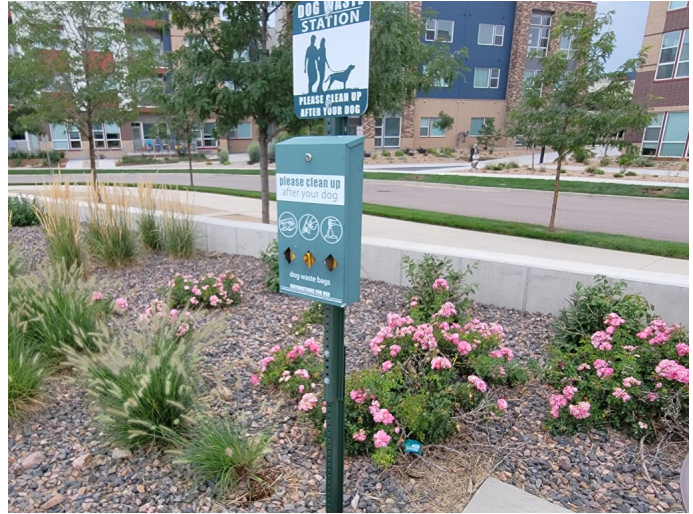
Comp #: 1311 Pet Waste Pick Up Stations - Replace

- Due to the varying ages of stations and low individual replacement cost of each station, it is an unlikely event that all will require replacement at the same time
- Therefore, we do not recommend reserving for replacement at this time.
- Maintain and replace on an as needed basis using operating funds.

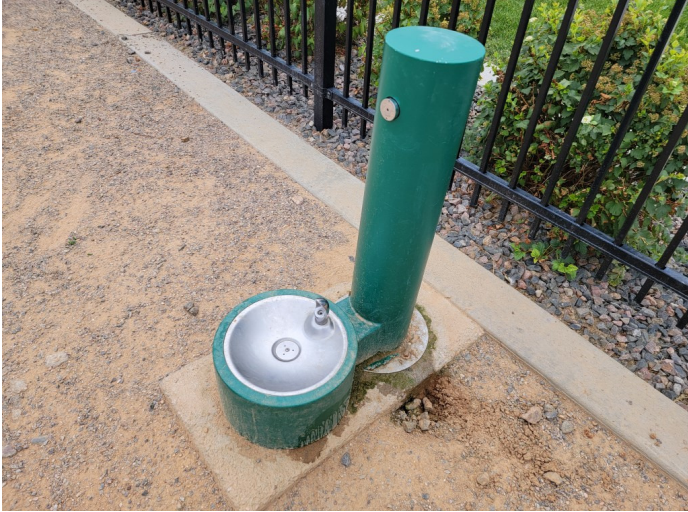
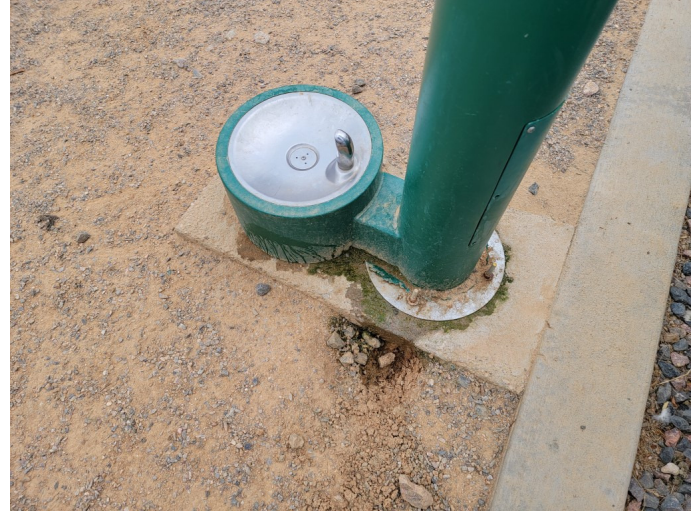
Comp #: 1320 Dog Park Fountain - Replacement

- Fountain was recently refurbished for an unknown reason.
- In our experience, we have seen these fountains have a life expectancy of 8 - 12 years under normal conditions.
- Winterize these units in a timely manner before the weather turns and overnight temperatures drop below freezing.

Estimate to replace/restore fountain

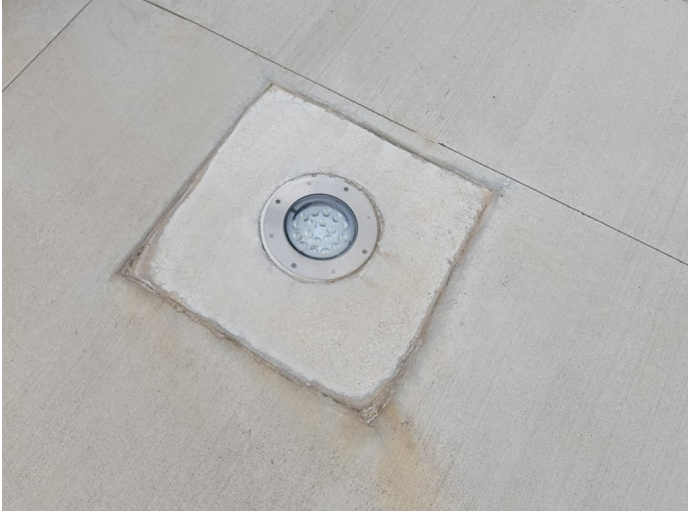
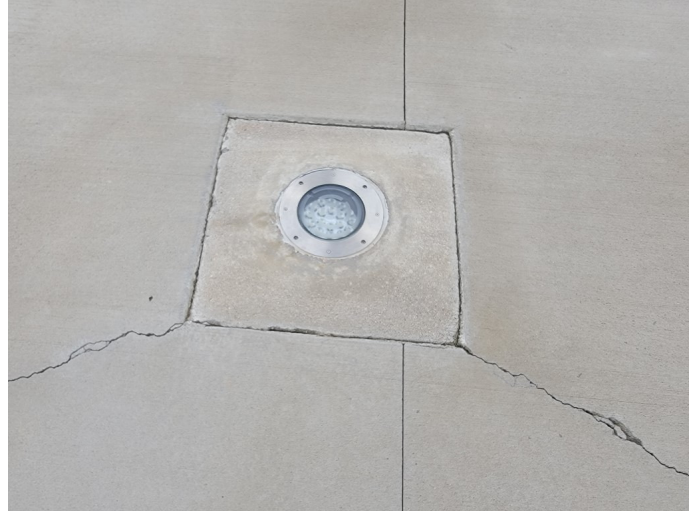
Comp #: 1603 Recessed LED Uplights - Replace

- Due to low quantity and inexpensive replacement cost, we recommend addressing replacement of these lights on an as needed basis with general operating funds.

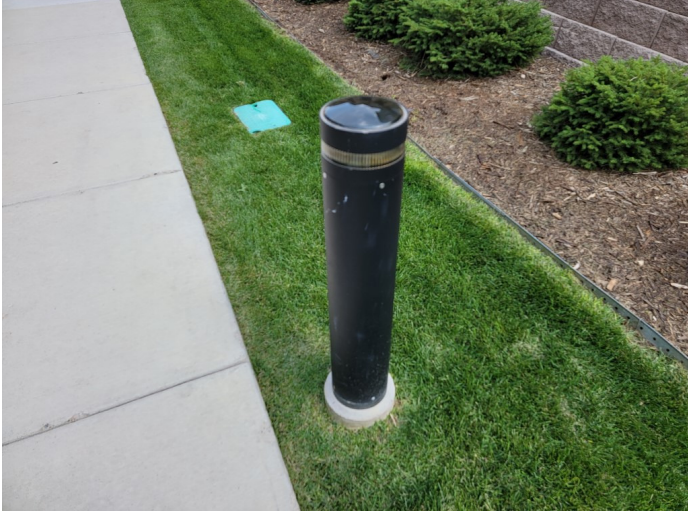
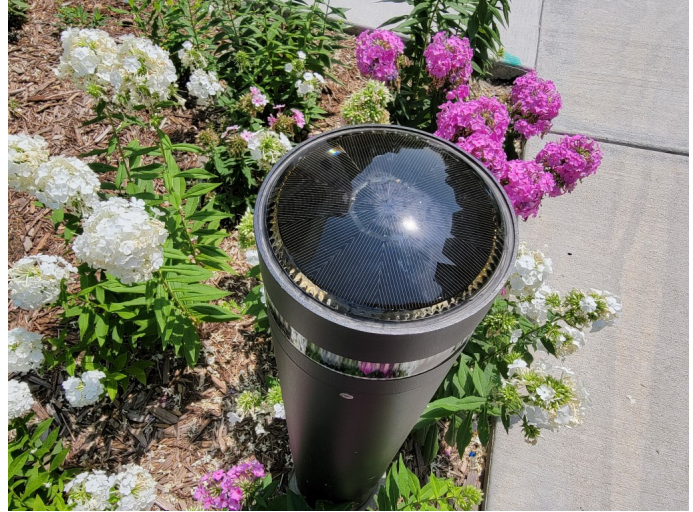
Comp #: 1605 Bollard Lights - Replace

- The average life expectancy for this type of light ranges between 12 - 18 years, depending on quality of light, exposure to elements, and level of care.

\$825/fixture; Estimate to replace and install

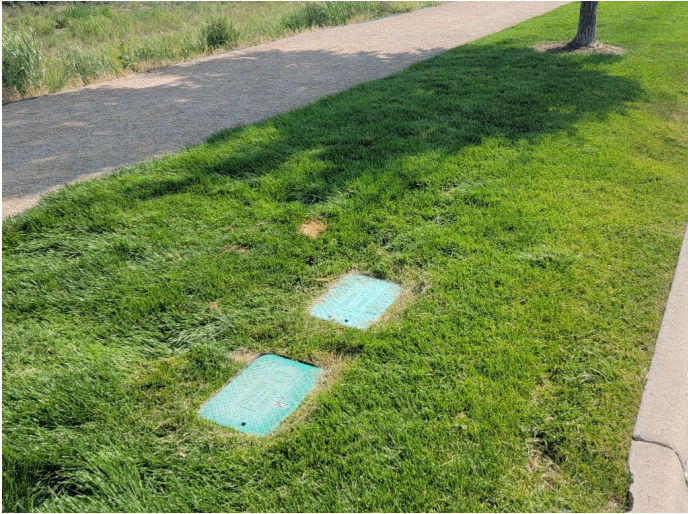
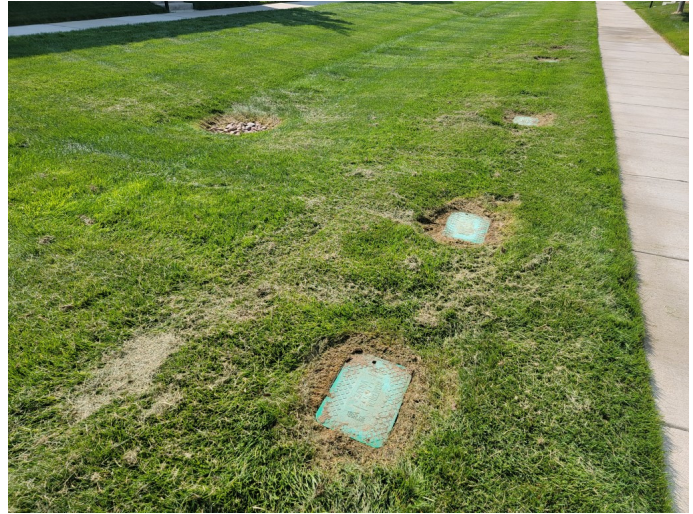
Comp #: 1701 Irrigation System - Major Repairs

- This line item is for repairs and replacement that lies outside the scope of routine maintenance: bulk sprinkler head replacement, bulk valve replacement, rerouting lateral lines, rewiring, etc.
- In order to ensure the funds are available for major repairs, we recommend reserving funds for these projects every 4 - 5 years.
- The funding on this line item is for major repairs and is not to be interpreted as complete irrigation system replacement.

Estimate for major repairs and renovating system

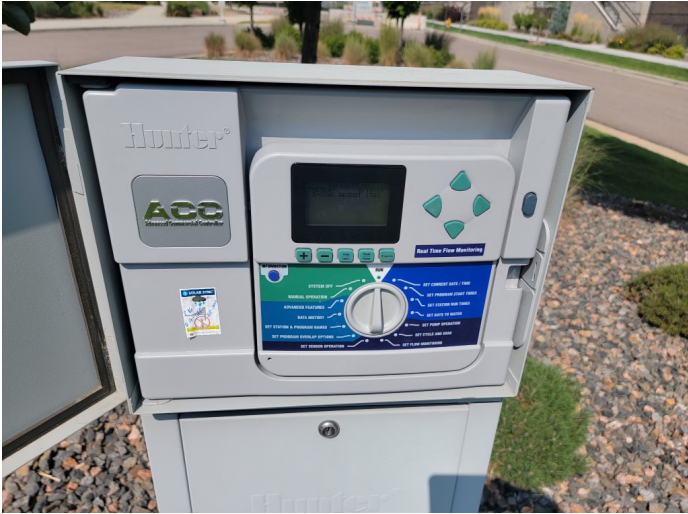
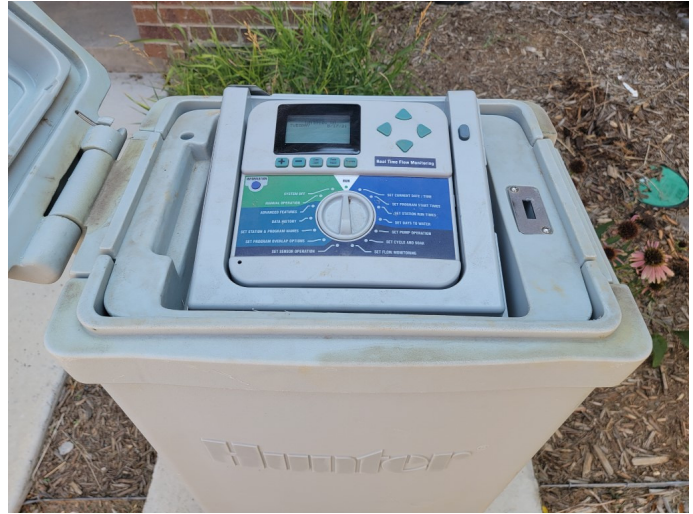
Comp #: 1703 Irrigation Controllers - Replace

- Expect to replace irrigation controllers every 10 - 15 years if properly maintained and under normal conditions.
- Funding is for replacement with a similar controller.
- Remaining life is based on average age of all controllers.

Best Cost: *\$11,550*
 \$1650/controller; Estimate to replace

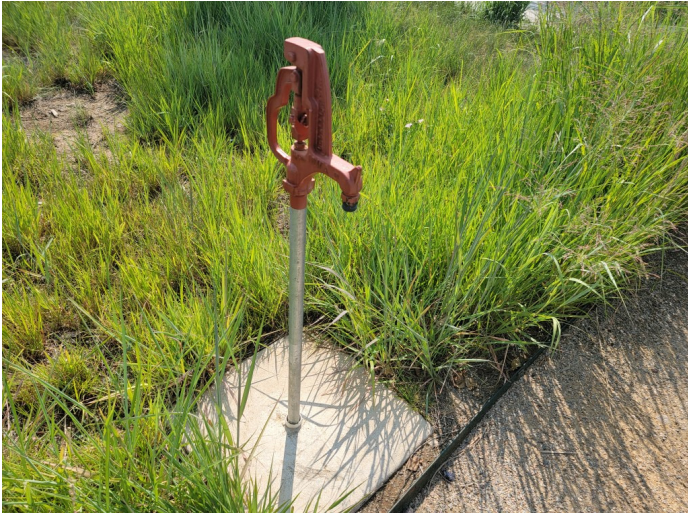
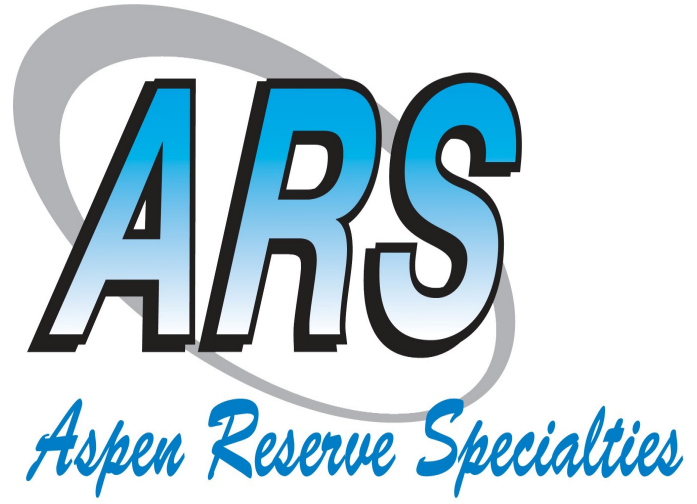
Comp #: 1705 Water Hand Pumps - Replace

- No unusual conditions reported or observed at time of field work.
- These have an indefinite life expectancy and replacement is unlikely under normal conditions.
- We recommend treating any repairs and/or replacement on an as needed basis with general operating funds.

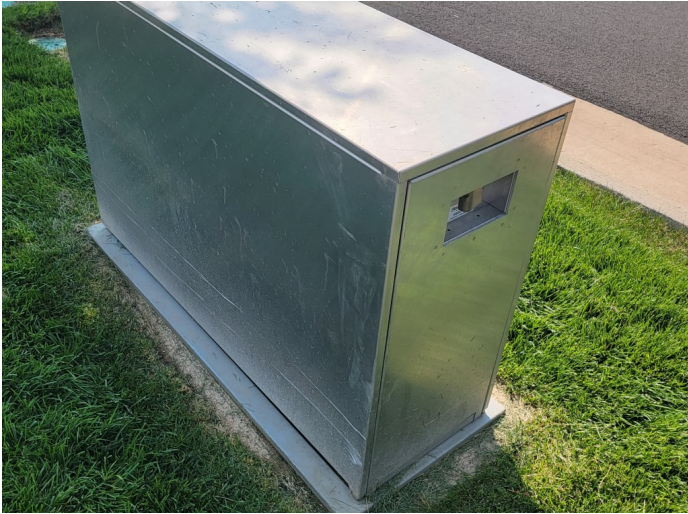
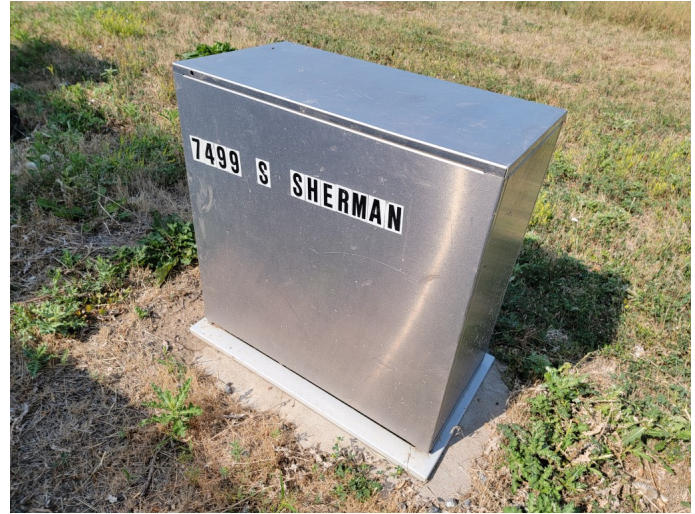
Comp #: 1706 Backflow Devices - Replace

- All devices are enclosed in a protective stainless steel enclosure to prevent theft. No reported problems with any of the devices.
- Due to the ability to rebuild and replace these devices for a relatively low cost and the fact that failure of the device is unpredictable, we do not recommend reserving for replacement.
- Repair and/or replace these devices/enclosures on an as needed basis using operating funds.

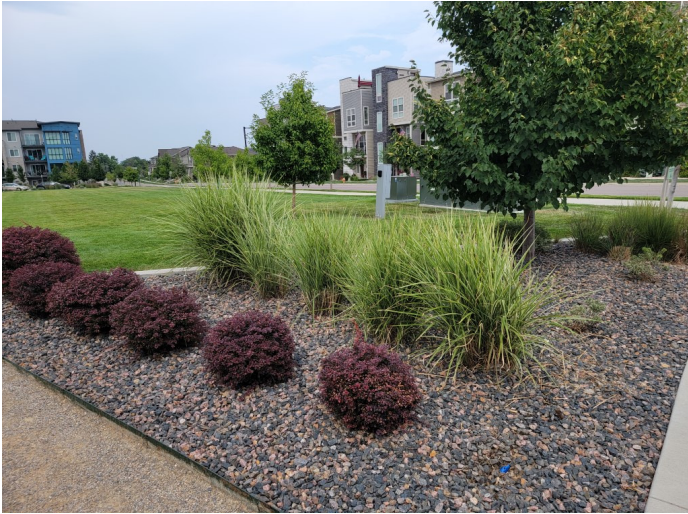
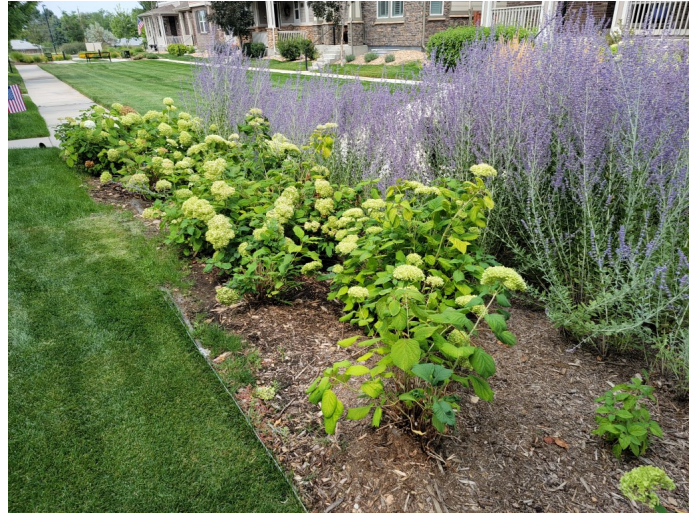
Comp #: 1801 Groundcover - Replenish

- This line item, similar to irrigation repairs, is for projects that lie outside the scope of routine maintenance.
- In order to preserve an attractive curb appeal and to maintain the health of the plants and shrubs, we recommend reserving for refurbishment projects every 2 - 4 years.
- This line item is for cyclical refurbishment and should not be considered as complete landscaping replacement.

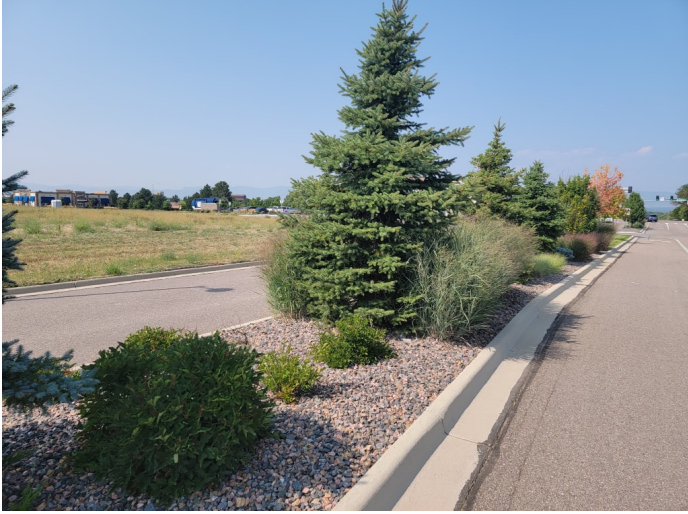
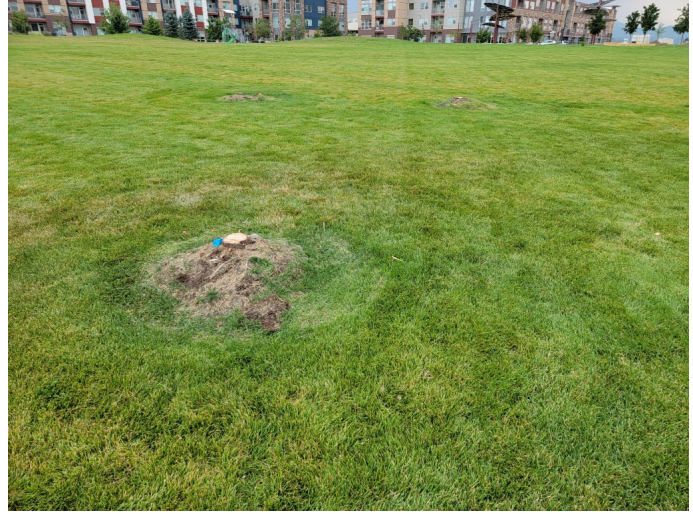
Comp #: 1804 Tree - Replacement/Major Maintenance

- Several trees were cut down at the park, but have not been replaced yet.
- It is very difficult to predict a replacement cycle for trees as there are several factors that will contribute to a tree dying.
- Factors such as disease, infestation of insects, heavy snow storms, etc. can all attribute to eventual tree replacement.
- Since it is difficult to predict when the replacement will be necessary, Reserve funding is typically not a factor.
- However, based on our recent experience, an allowance for periodic replacement has been included.

Allowance for major maintenance/replacement

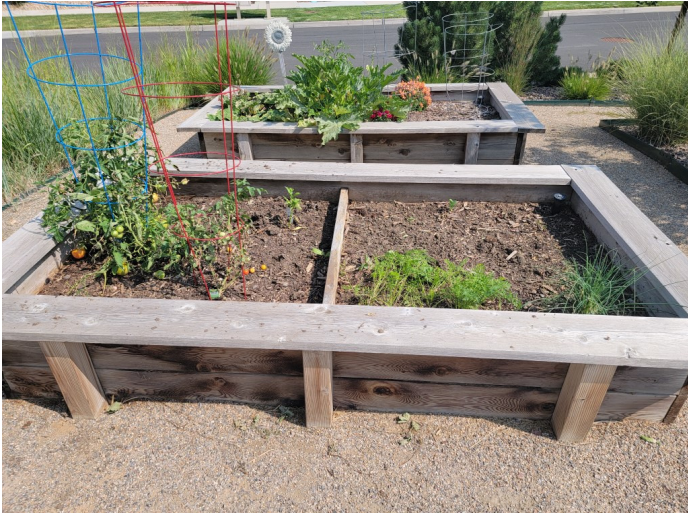
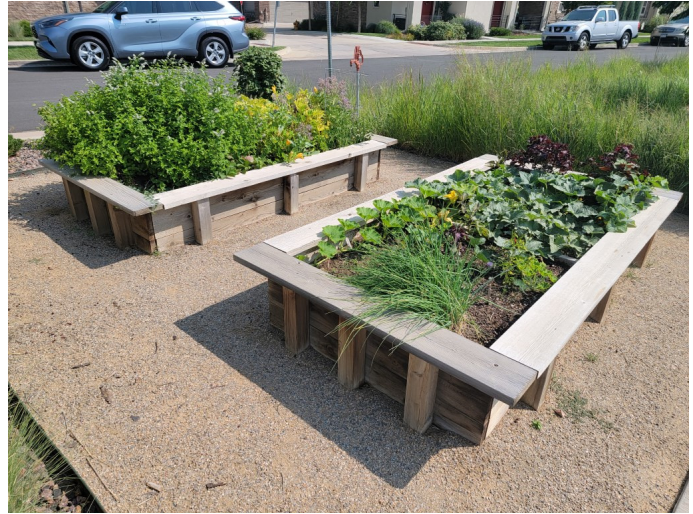
Comp #: 1812 Planter Boxes - Rebuild

- A few boards were starting to warp, but all planters are intact and in good shape.
- While it is possible to repair the boards as needed, we suggest establishing a line item for major repairs and rebuilding every 12 years at this time.
- If deterioration rates differ in future updates, then we can continue to adjust this line item accordingly. It is possible this item becomes an operating expense as rotted boards are replaced as needed.

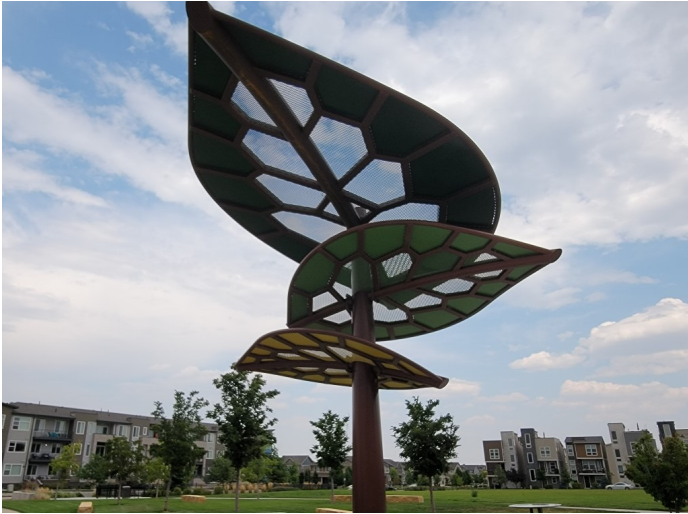
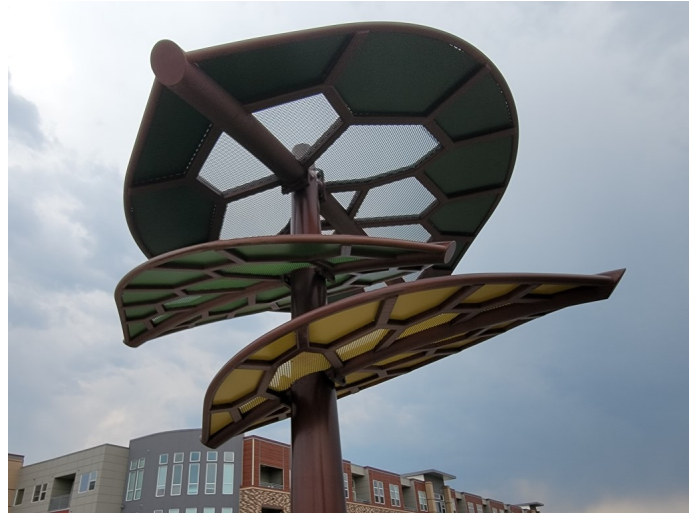
Comp #: 1813 Steel Leaf Structures - Replace

- These art structures should have an indefinite life expectancy and replacement is unlikely under normal conditions.
- Continue to monitor deterioration rates and adjust in future Reserve Study updates if necessary.
- At this time, Reserve funding is not required for this component
