Level 1, Premium Reserve Analysis

Littleton Village Metro District No. 2 Dry Creek & Broadway Littleton, CO. 80120

FINAL VERSION

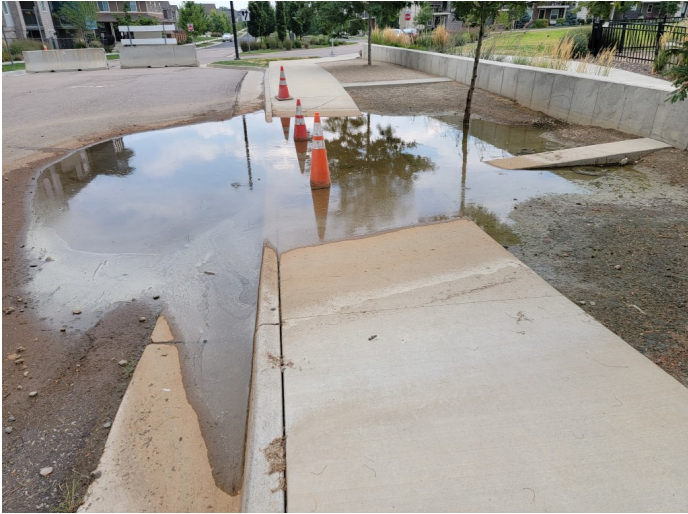
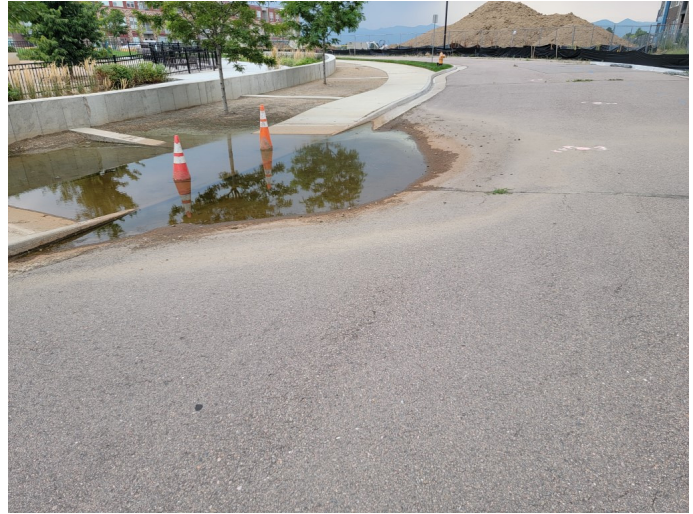
Comp #: 2035 Sink Hole

Recent discussions and policy decisions made by the City of Littleton have resulted in the removal of the E. Hinsdale Avenue sinkhole repair in this reserve study. The City of Littleton will be making this repair and the District's financial obligation will be realized in years outside the scope of this study and will be obtained through property tax revenue. The anticipated financial obligation is \$250,000 and will be done as part of the District's bond financing, terms of which will be determined at a later date.
